410 Widdington Lane
Pre Listing Inspection Report

Home Inspection Report

PROPERTY INSPECTED:
**410 Widdington Lane
Cary, NC 27519**

Date of Inspection: 01/27/2026

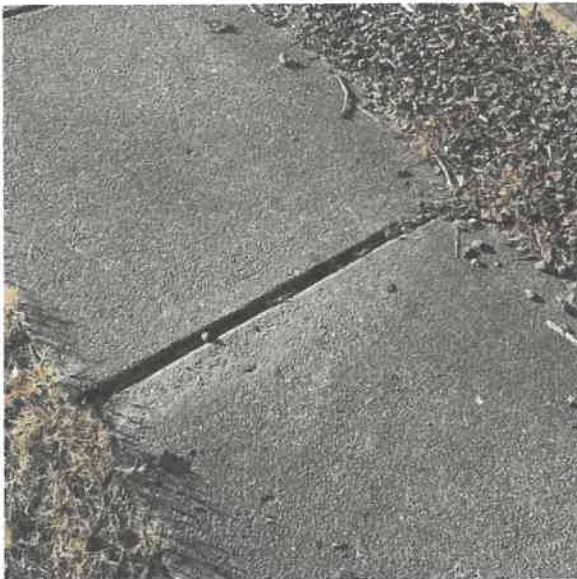
2.3.2 **The uneven walkway is a trip hazard. This should be corrected for safety.**

2.3, 2.4 Uneven walkway and cracked driveway repaired by Triangle Reconstruction (Invoice #1)

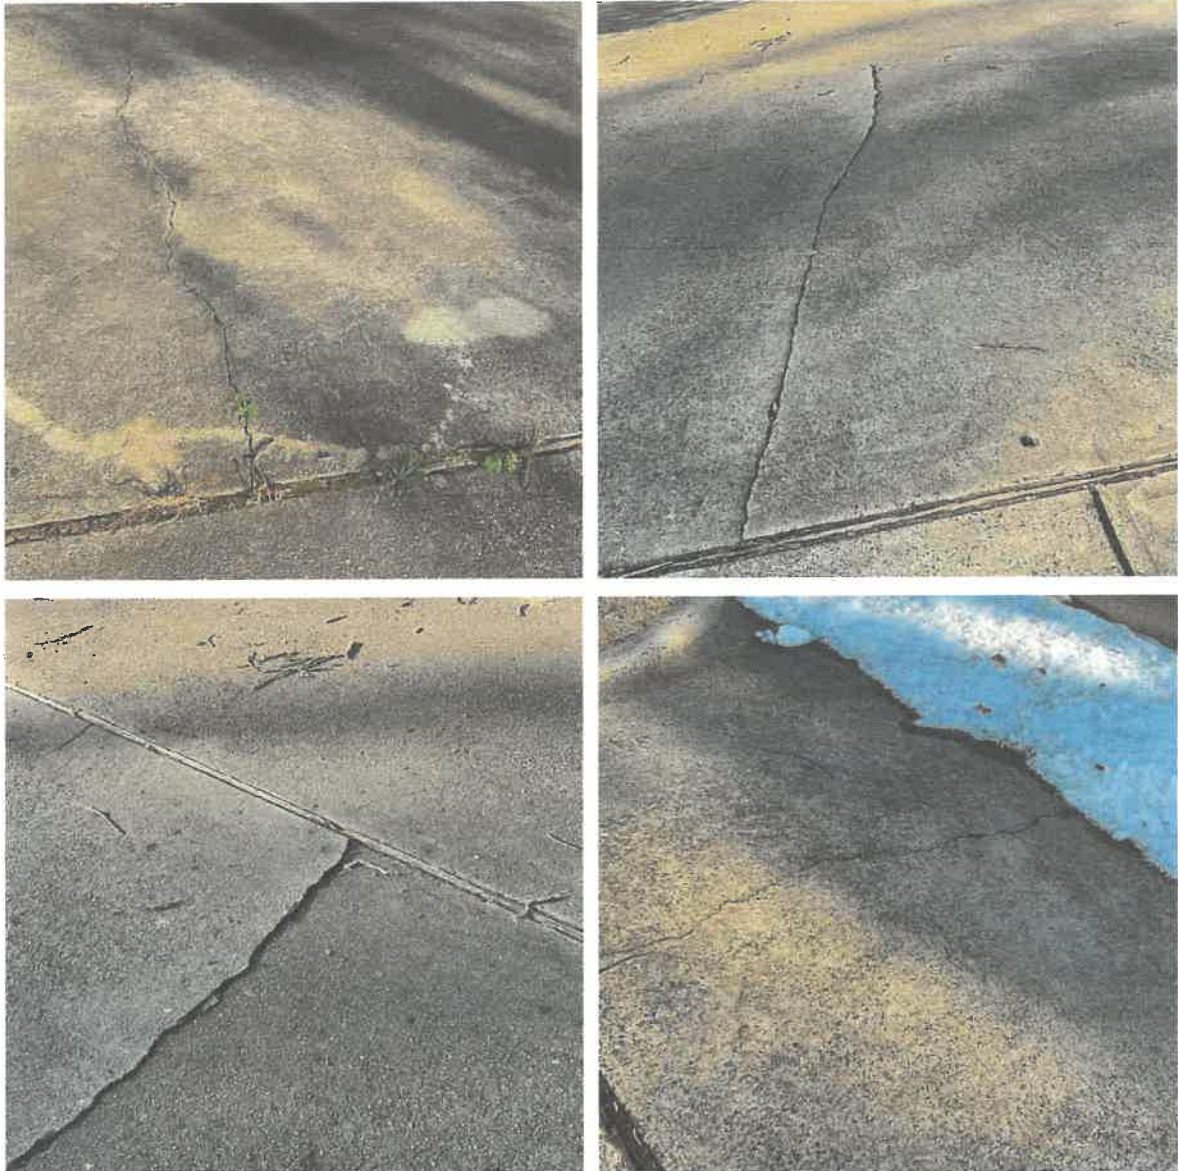
2.4.1 **Cracks were visible in the driveway. Cracks allow water to penetrate under the slab and cause movement. Recommend having a licensed contractor repair cracks to reduce moisture intrusion and further damages.**

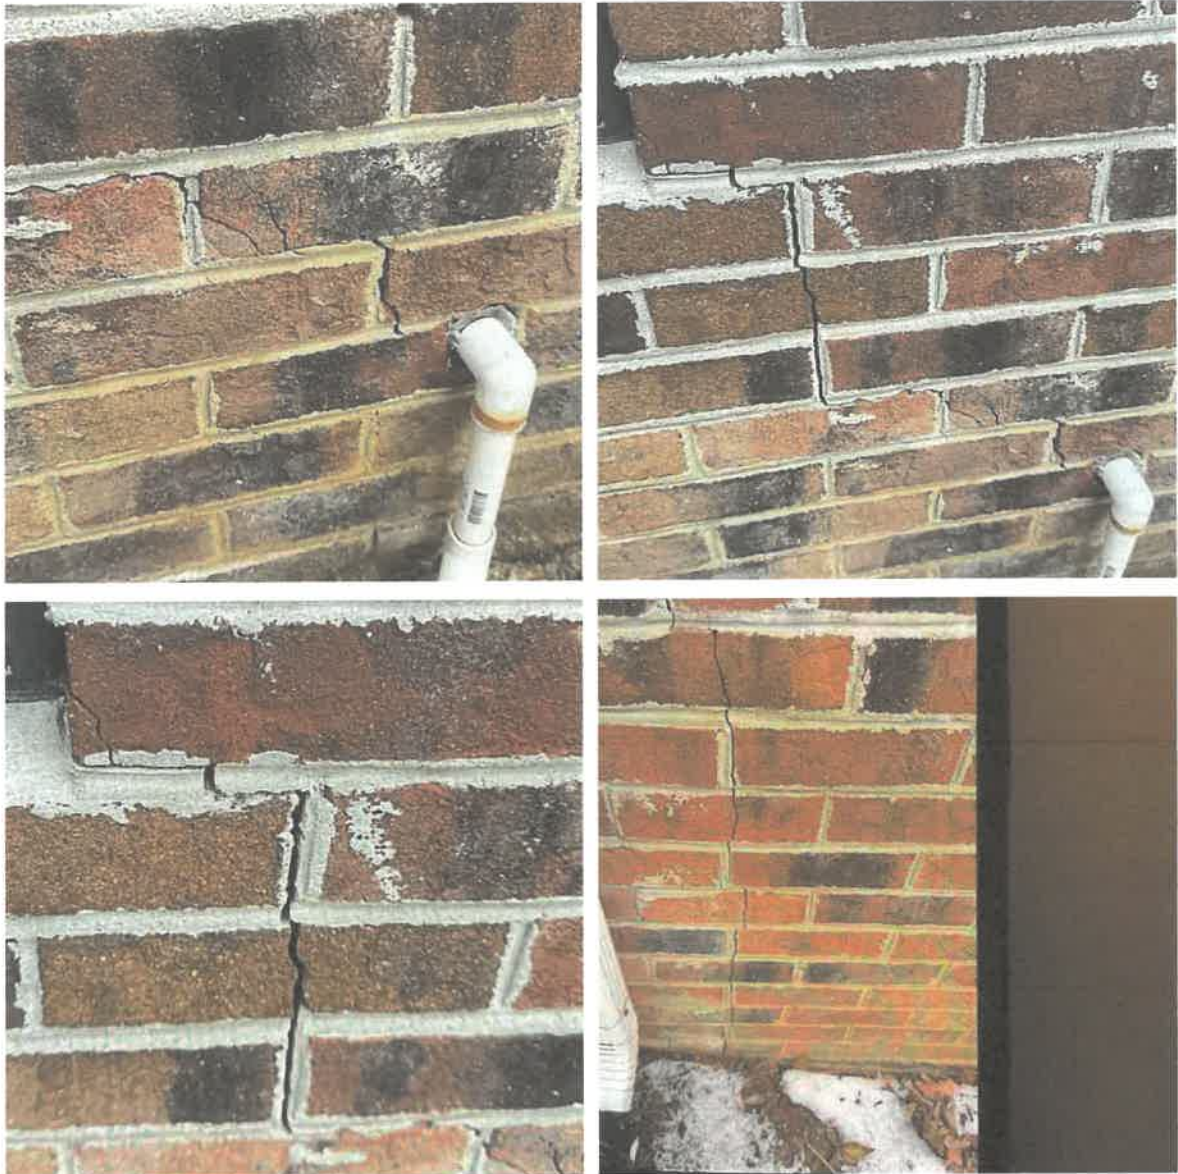
3.2.2 Foundation crack was visible on the foundation wall at the rear of the house under the kitchen area. Cracks indicate settlement and can also result in water intrusion into the structure. Recommend pointing up the mortar and monitoring the cracked brick.

3.2 Foundation crack repaired by Triangle Reconstruction (Invoice #1)

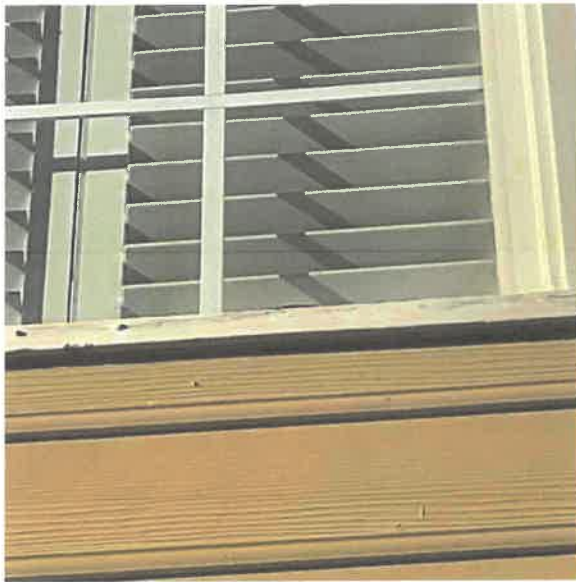
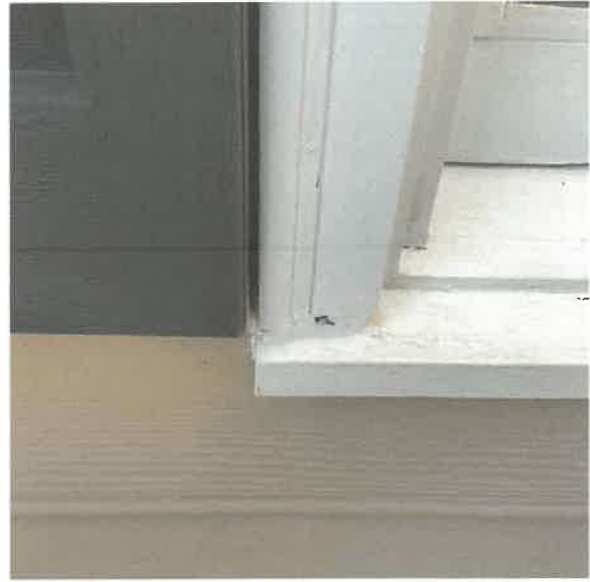
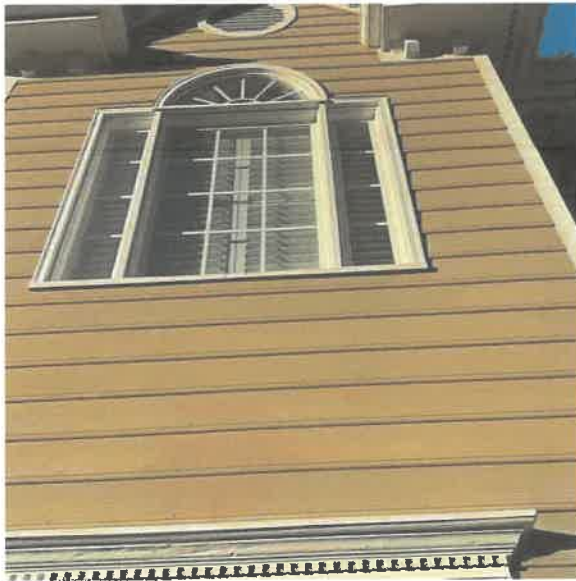
3.6.2 Wood rot identified in areas. This should be repaired or replaced soon to minimize additional damage. The following is a partial list of areas that will require repair: Dining room window sill, large window sill above the front door.

3.6.2 Wood rot repaired (Invoice #2)

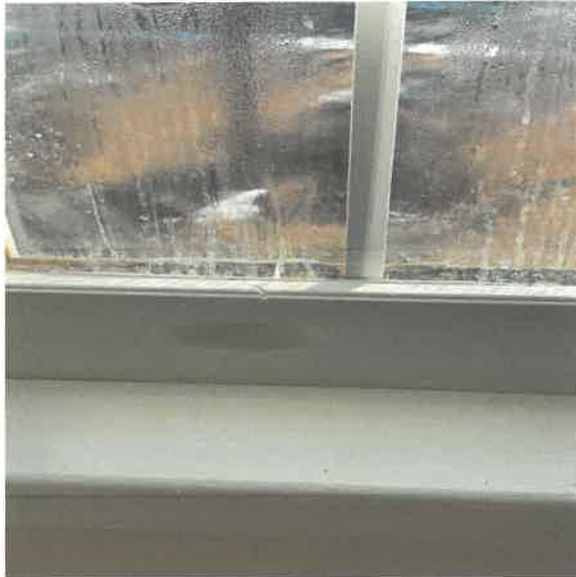
3.6.3 Window in the primary bedroom has failed thermal seal. Replace, if desired, as this is a cosmetic issue.
(Primary Bedroom)

3.6.3 Window in primary bedroom and living room with failed seals repaired (Invoice #3)

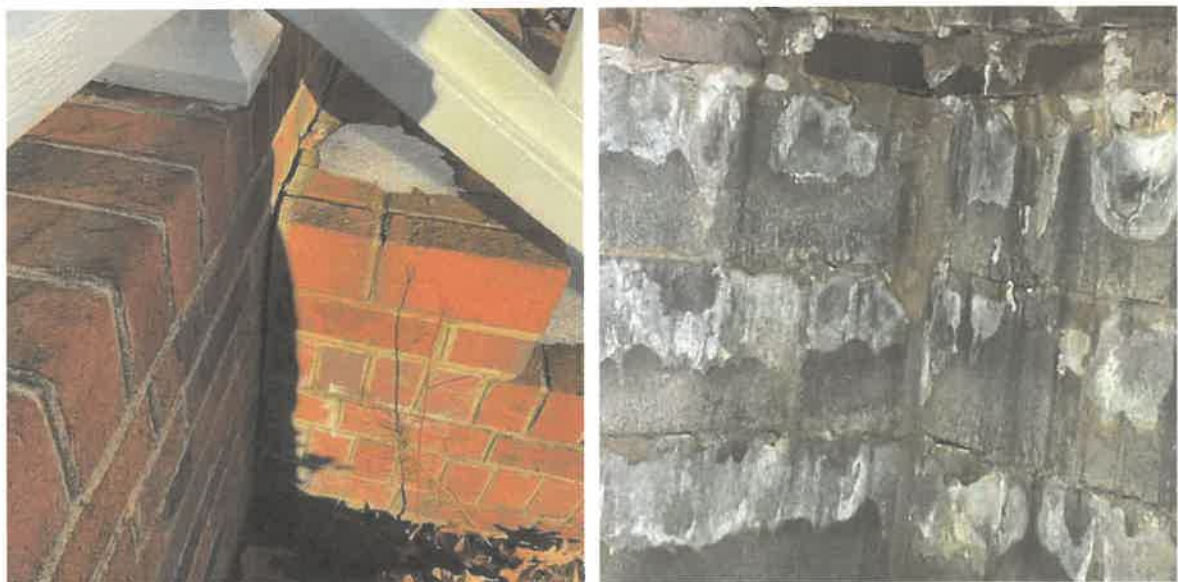
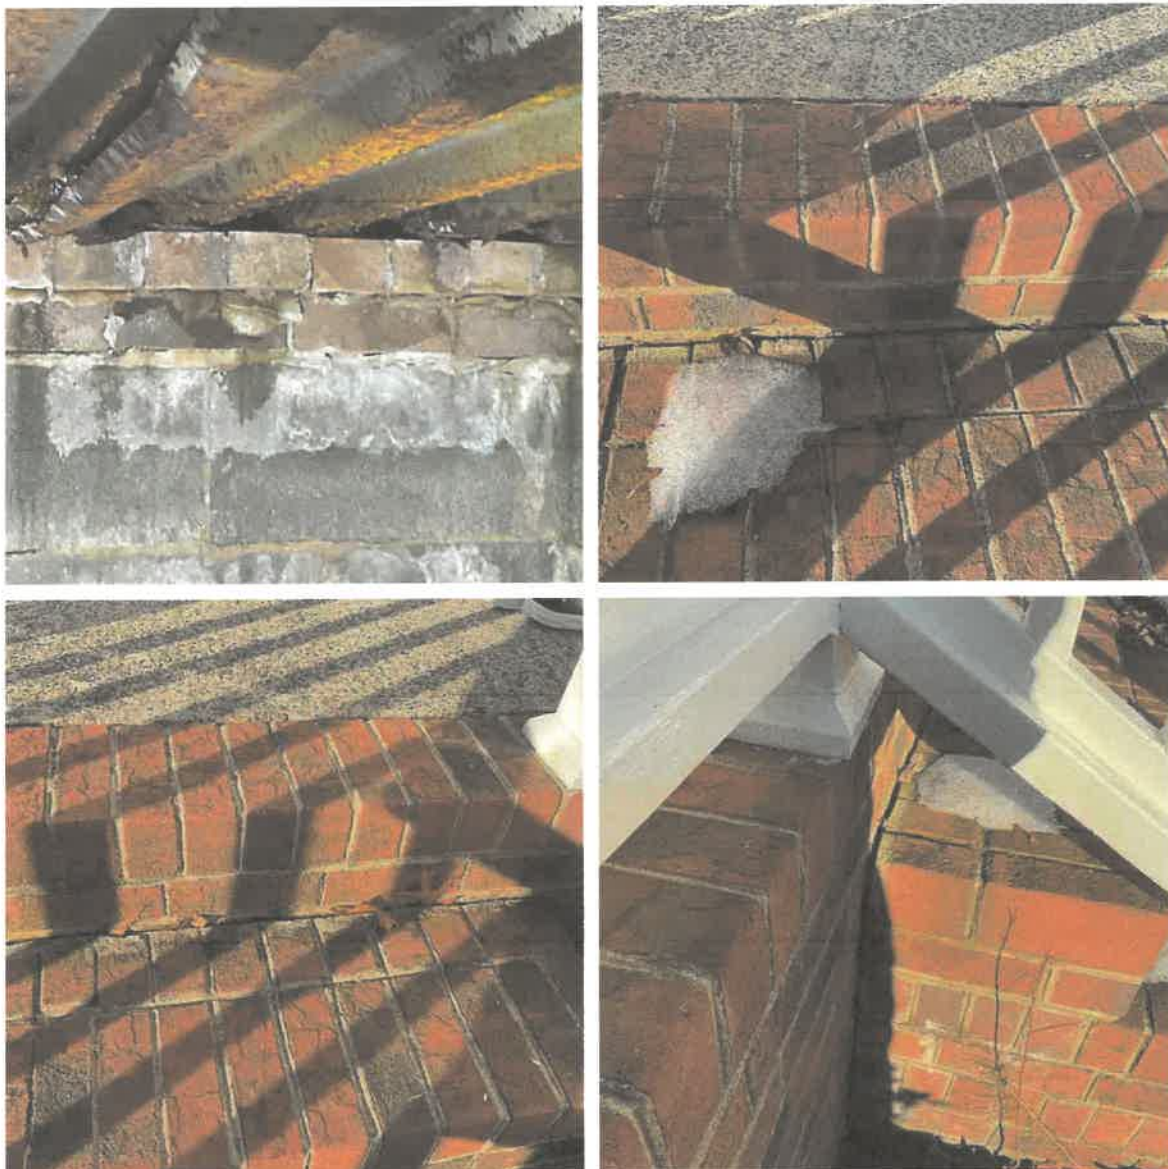
3.8.1 • **Gaps were visible in the brick porch steps. This can allow water to penetrate which can cause the bricks to come loose once the moisture freezes/thaws. Have a licensed contractor repoint the missing mortar joints in the front porch steps to reduce moisture intrusion, resulting in the future damages from freeze/thaw conditions.**

• **The front porch steps have settled away from the front porch, resulting in them becoming detached from the porch. This has created an area for water to infiltrate behind the steps and under the porch causing efflorescence and moisture in the crawlspace. Over time, additional settling can occur, causing further damages to the porch and crawlspace. Recommend having a licensed and insured masonry contractor repair to reduce future hazard/damages. Recommend having the efflorescence in the crawlspace underneath the porch mitigated by a basement/foundation mitigation professional.**

3.8 Gaps in brick porch steps and settlement away from porch repaired by Triangle Reconstruction (Invoice #1)

3.8.1 Efflorescence in the crawlspace mitigated and repaired by Triangle Reconstruction (Invoice #1)

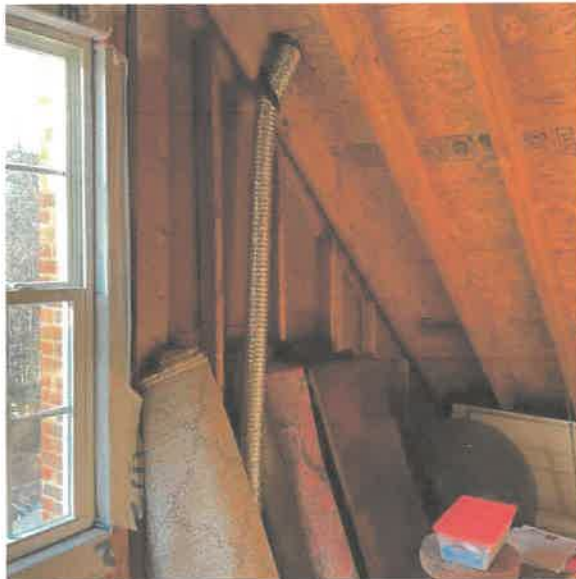
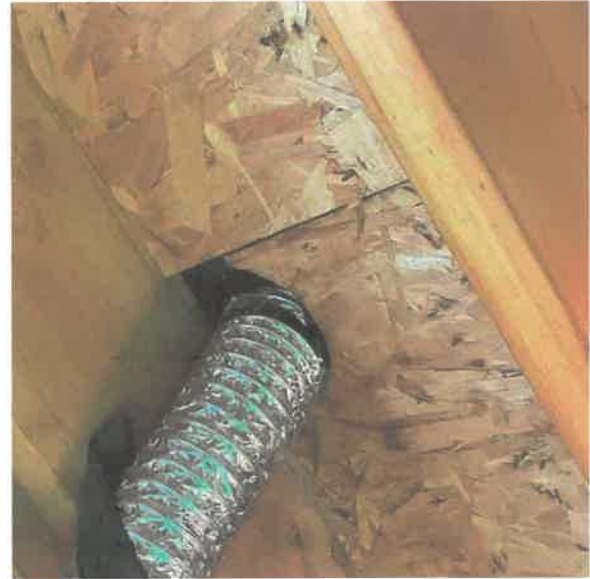
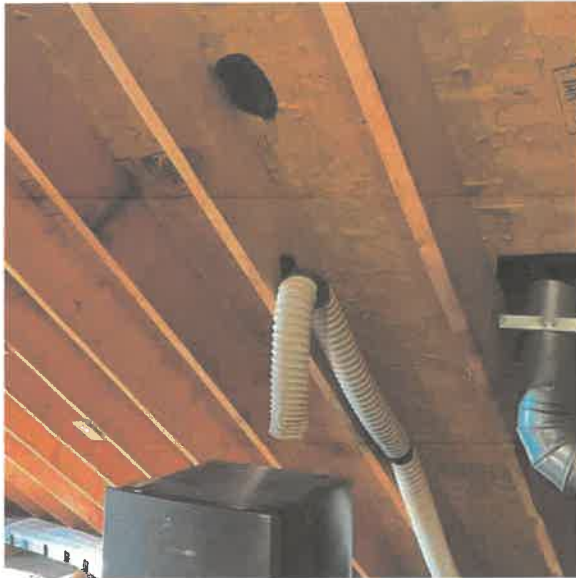
5.5.1 **The duct from the primary bathroom exhaust vent is torn and is currently venting into the attic. This can cause moisture buildup which can lead to fungal growth. Recommend having a licensed HVAC contractor repair/install new exhaust vent to discharge to the exterior through an approved vent to reduce moisture/condensation related damages.**

The exhaust vent for the hallway bathroom is disconnected from the roof vent cover at the time of the inspection of the attic. This can cause moisture buildup which can lead to fungal growth. Recommend having a licensed HVAC contractor reconnect and make any necessary repairs.

5.5 Exhaust duct from primary bathroom repaired. Exhaust duct from hallway bathroom replaced (Invoice #4)

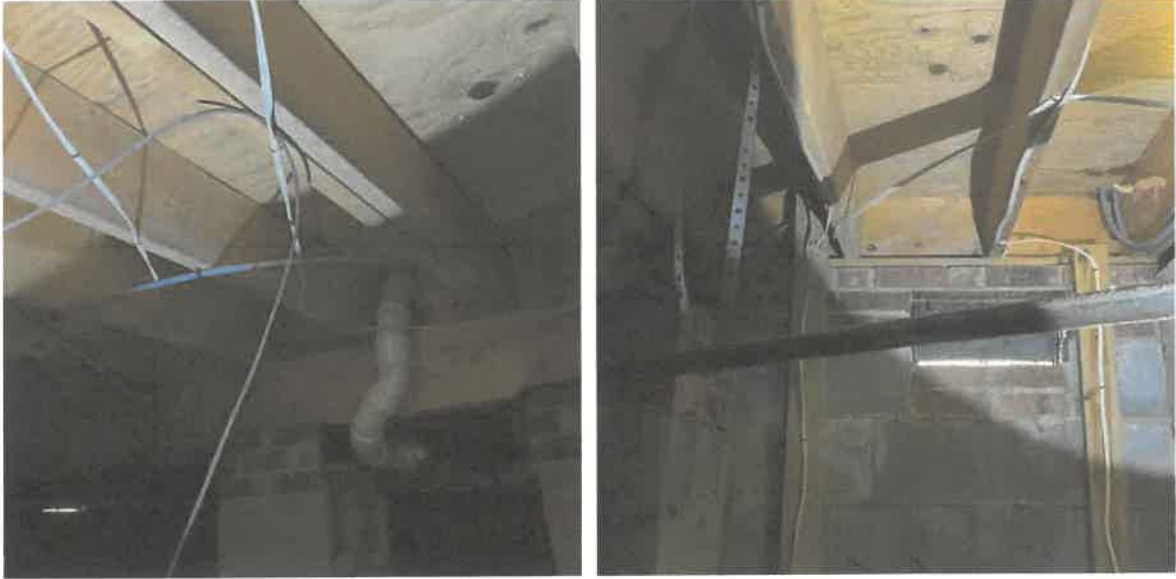
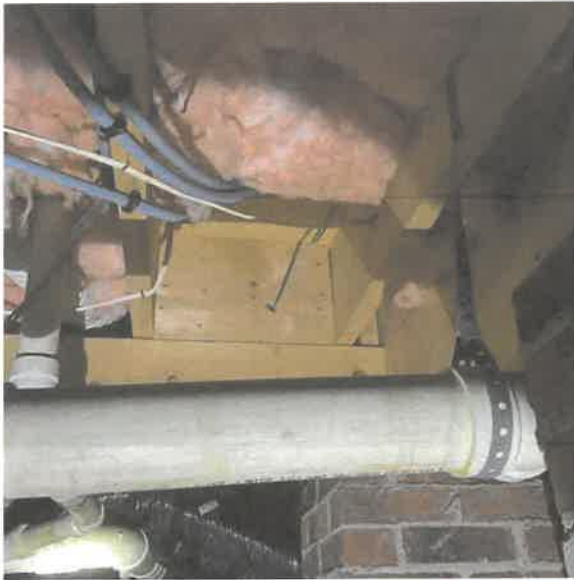
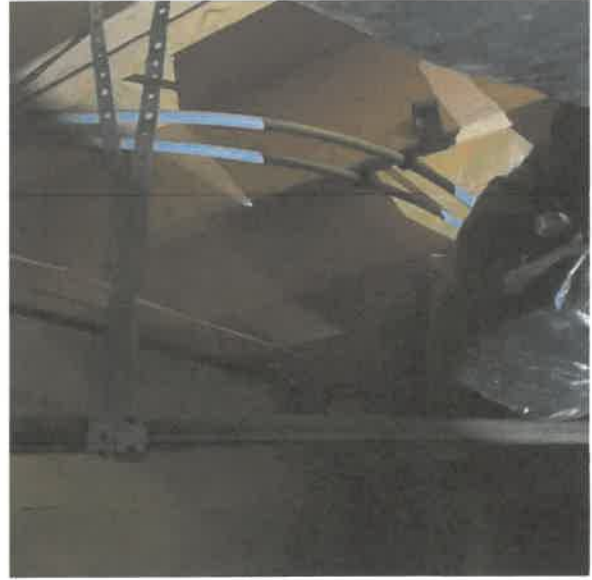
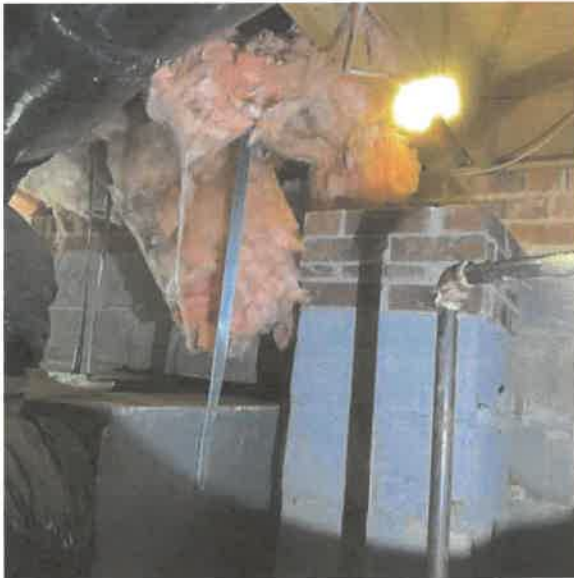
8.2.2 The insulation under the living room is missing and other areas of insulation are falling out of the joist bays. Missing or improperly installed insulation can cause heat/air loss leading to higher energy costs. Recommend having a licensed and insured insulation company make necessary repairs and replace the missing insulation.

8.2.2 Installed new insulation where missing (Invoice #1)

CS R-19 Insulation - Recommendation 8.2	Work detail- Install R-19 formaldehyde insulation free to any areas missing insulation under the home in the subfloor with tiger teeth.	300	\$1.99	\$597.00
Rehang Insulation - Recommendation 8.2	Work detail- Re hang falling insulation batts with tiger teeth	1	\$375.00	\$375.00
DryLok Foundation Wall	Work detail- Apply DryLock damp-proof paint on inside foundation wall	2	\$575.00	\$1,150.00

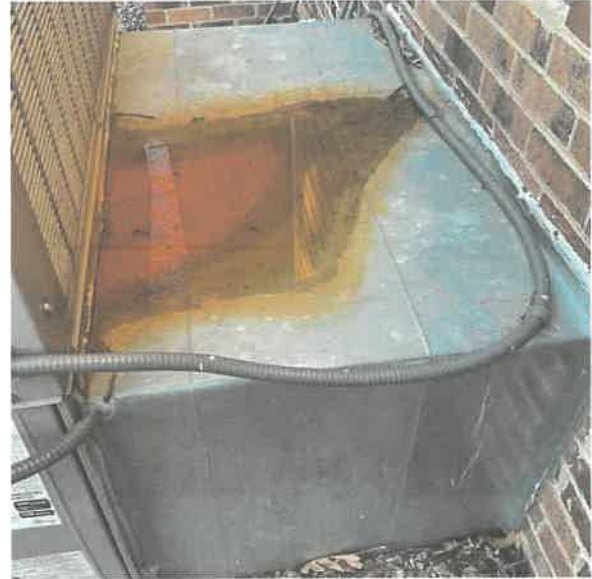
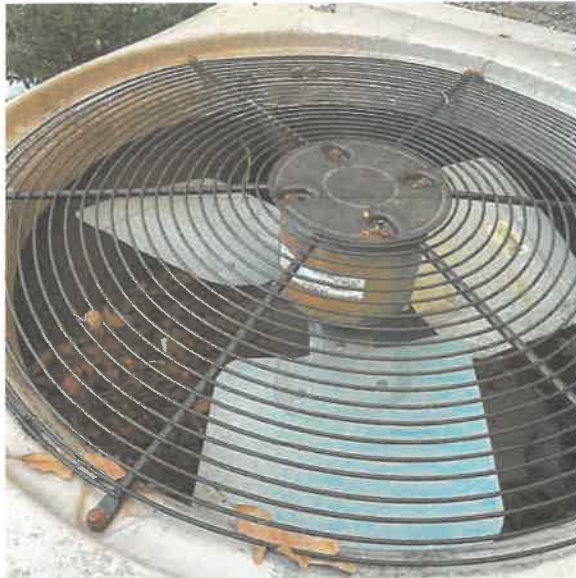
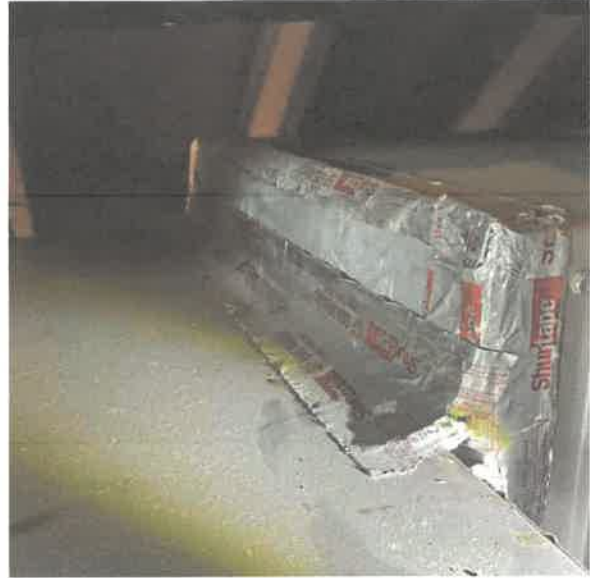
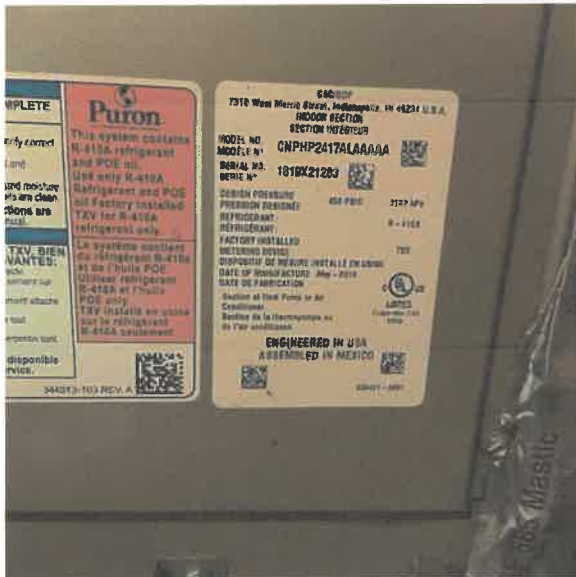
10.1.1 A/C unit not tested due to low outdoor temperatures. Determine function prior to cooling season. The air conditioning unit needs to be cleaned and serviced. The heating unit in the attic has a tear in the duct tape allowing air to escape into the attic. Recommend retapping the duct.

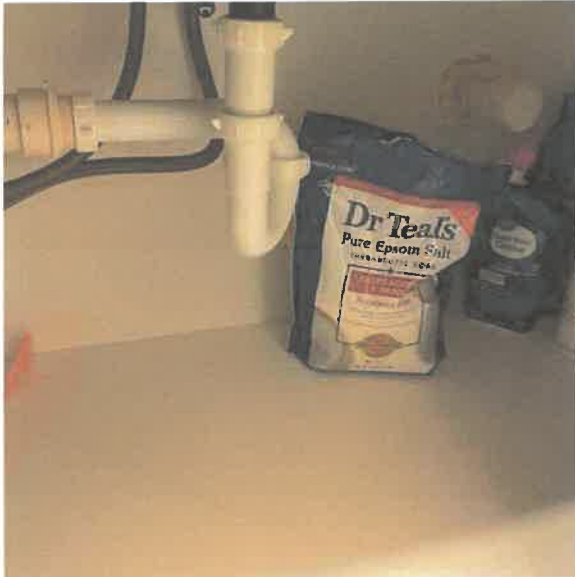
11.8.1 Leak was visible underneath sink. Any leak in the waste line can cause moisture damage to the cabinet. Have a licensed plumber repair as needed to reduce further water damages. Also the sink stopper doesn't operate as intended. **(Hallway Bathroom)**
